**PORT CHARLOTTE BEACH PARK
EROSION AND NAVIGATION CHANNEL STUDY
FINAL REPORT**

**Charlotte County Board of County Commissioners
18500 Murdock Circle
Port Charlotte, FL 33948-1094**

**June 15, 2022
CEC File No. 20.426**

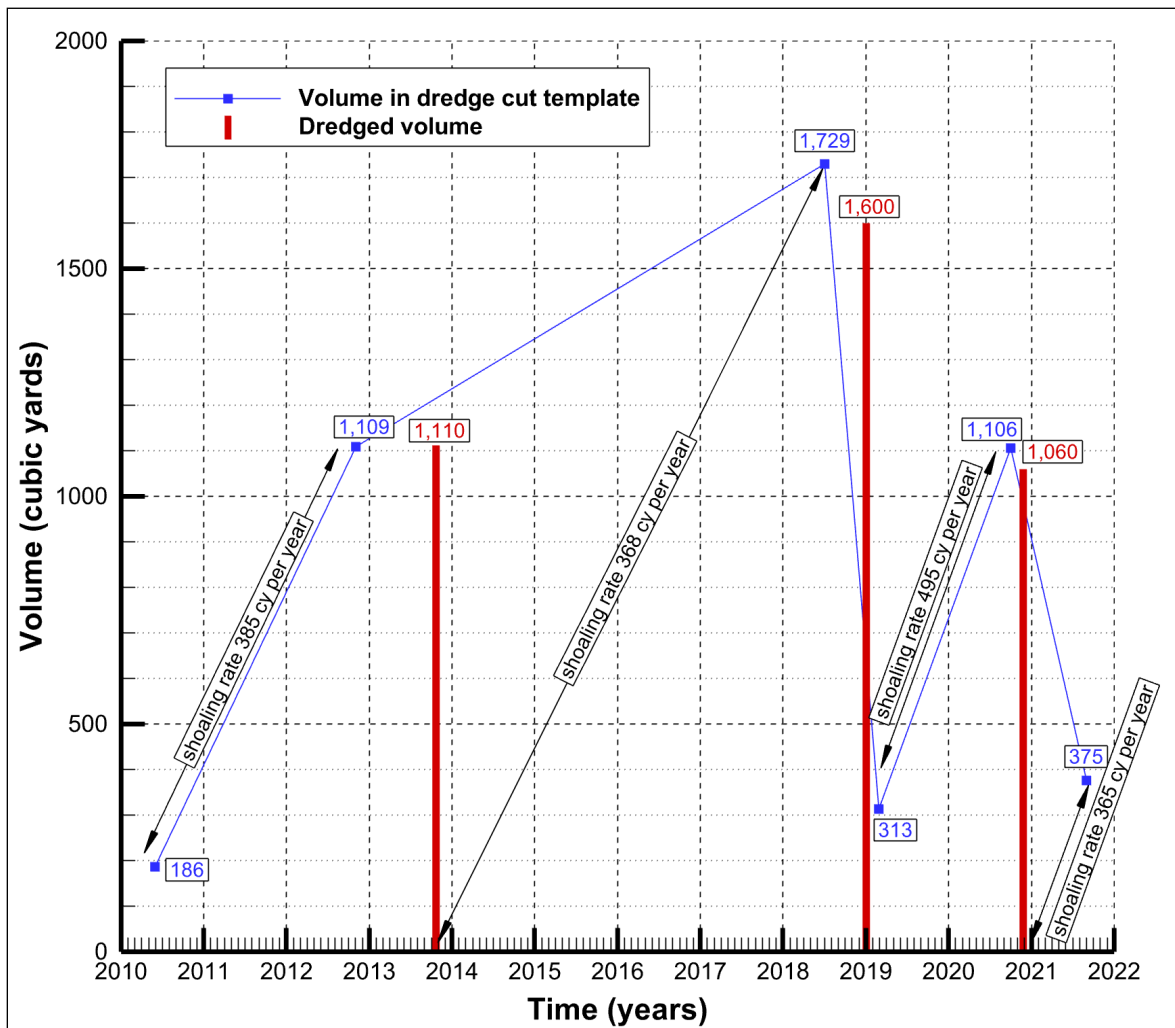
Figure 2. 2010-2022 Dredge Events and Surveyed Volumes within Dredge Template.

Table 2 presents the volume within the dredge template based on channel condition surveys along with the annualized shoaling rates of the channel. The shoaling rates ranged between 365 CY per year to 495 CY per year with the average rate of 403 CY per year. Taking into account the average volume removed during the dredging events since 2004, it takes on average 2 years and 4 months between dredging to maintain the channel.

Figure 2 presents a graph of dredging events with dredged volumes and the surveyed volumes within the dredge template between 2010 and 2022.
